HEAVY-LIFT BREAKBULK SHIP PRETEST RESULTS OF THE JOINT
LOGISTICS-OVER-THE- (U) ORI INC ROCKVILLE MD
H CASEY ET AL. 25 JUL 77 ORI-TR-1168 MDA903-75-C-0016

25 JULY 1977

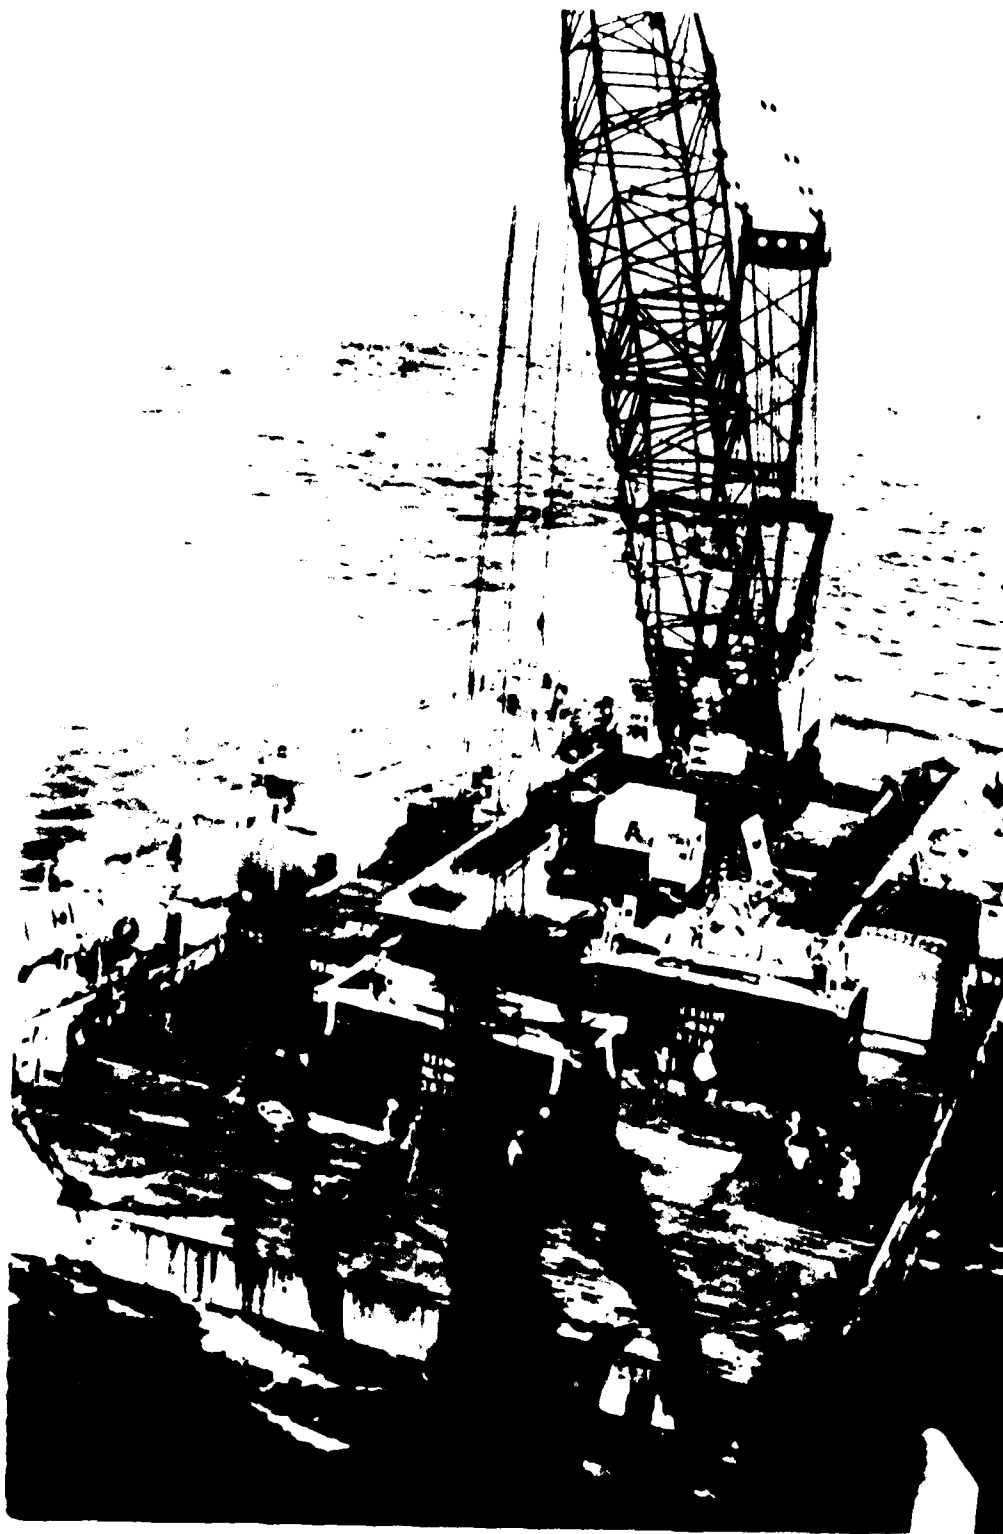
FIGURE 3. TEMPORARY CONTAINERSHIP DISCHARGE FACILITY

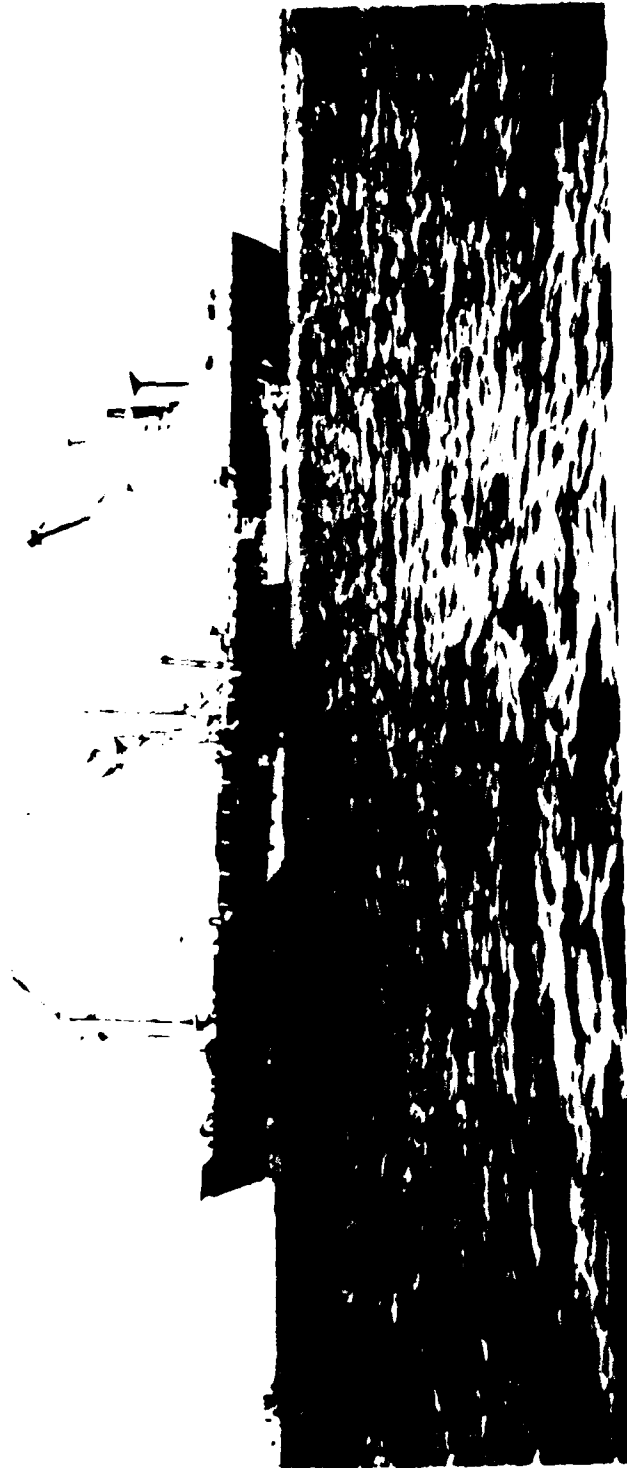
FIGURE 1. S.S. TRANSCOLUMBIA, KING PIERCE. The S.S. TRANSCOLUMBIA, one of two heavy-lift breakbulk ships under long-term charter to the Ministry of Defense, was used November 2-7, 1974, for the third of three exercises. The primary objective of the exercise was to load 100,000 heavy and oversized equipment and harbor, and as it from the ship at anchor in the pier sea, and distribute it ashore for the conduct of the same carrier throughout operations.

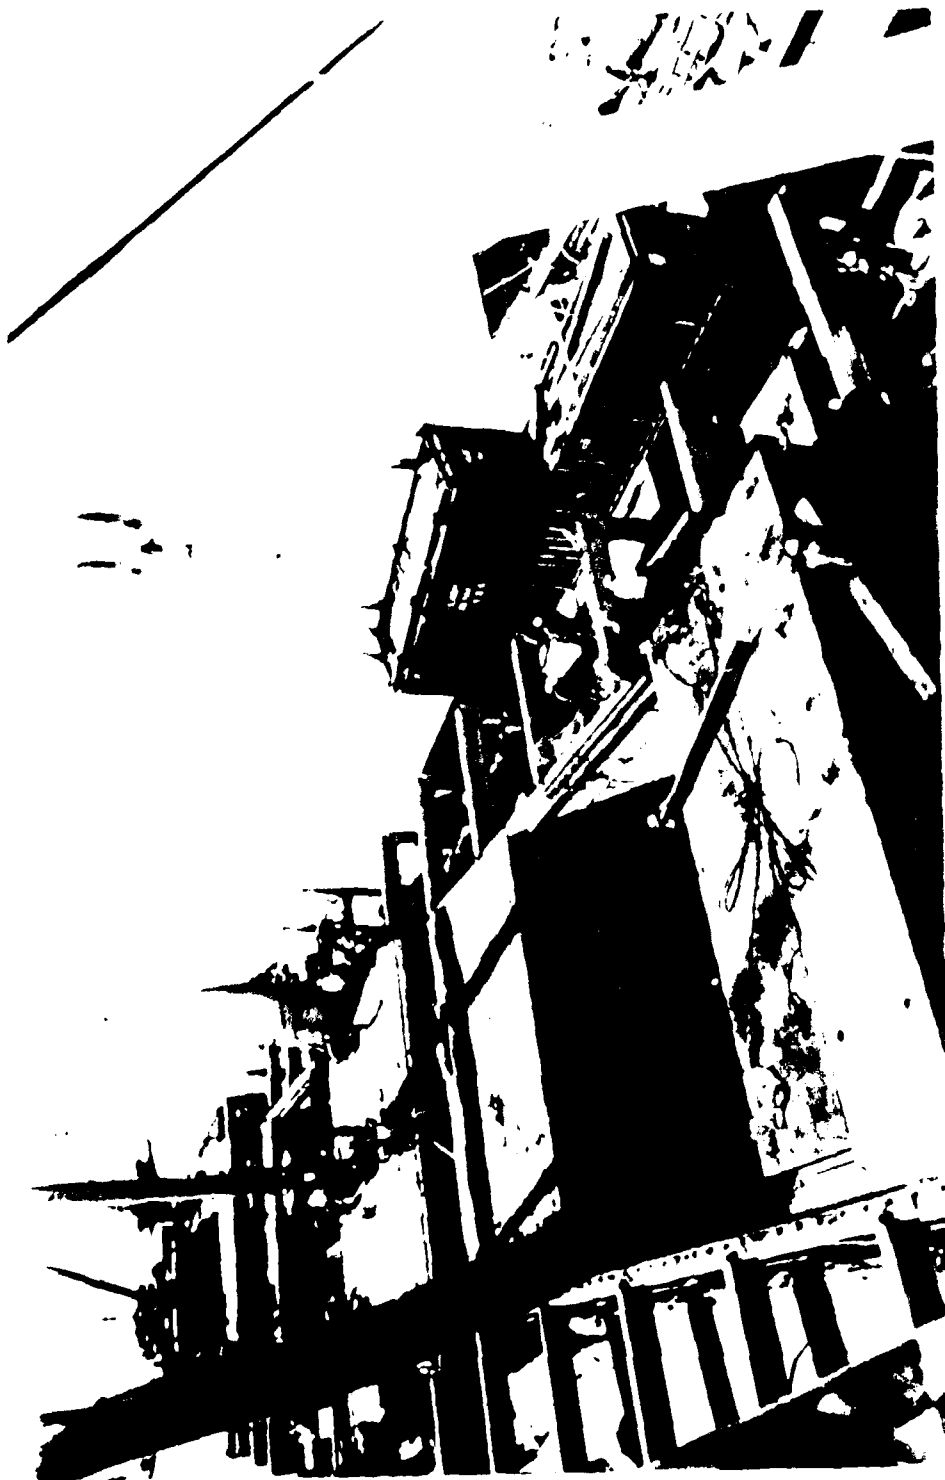
FIGURE 3.4. 40-FT CONTAINER. One 40-ft container was included in the load to provide data and experience in handling a 40-ft container which weighed 14,100 lbs.

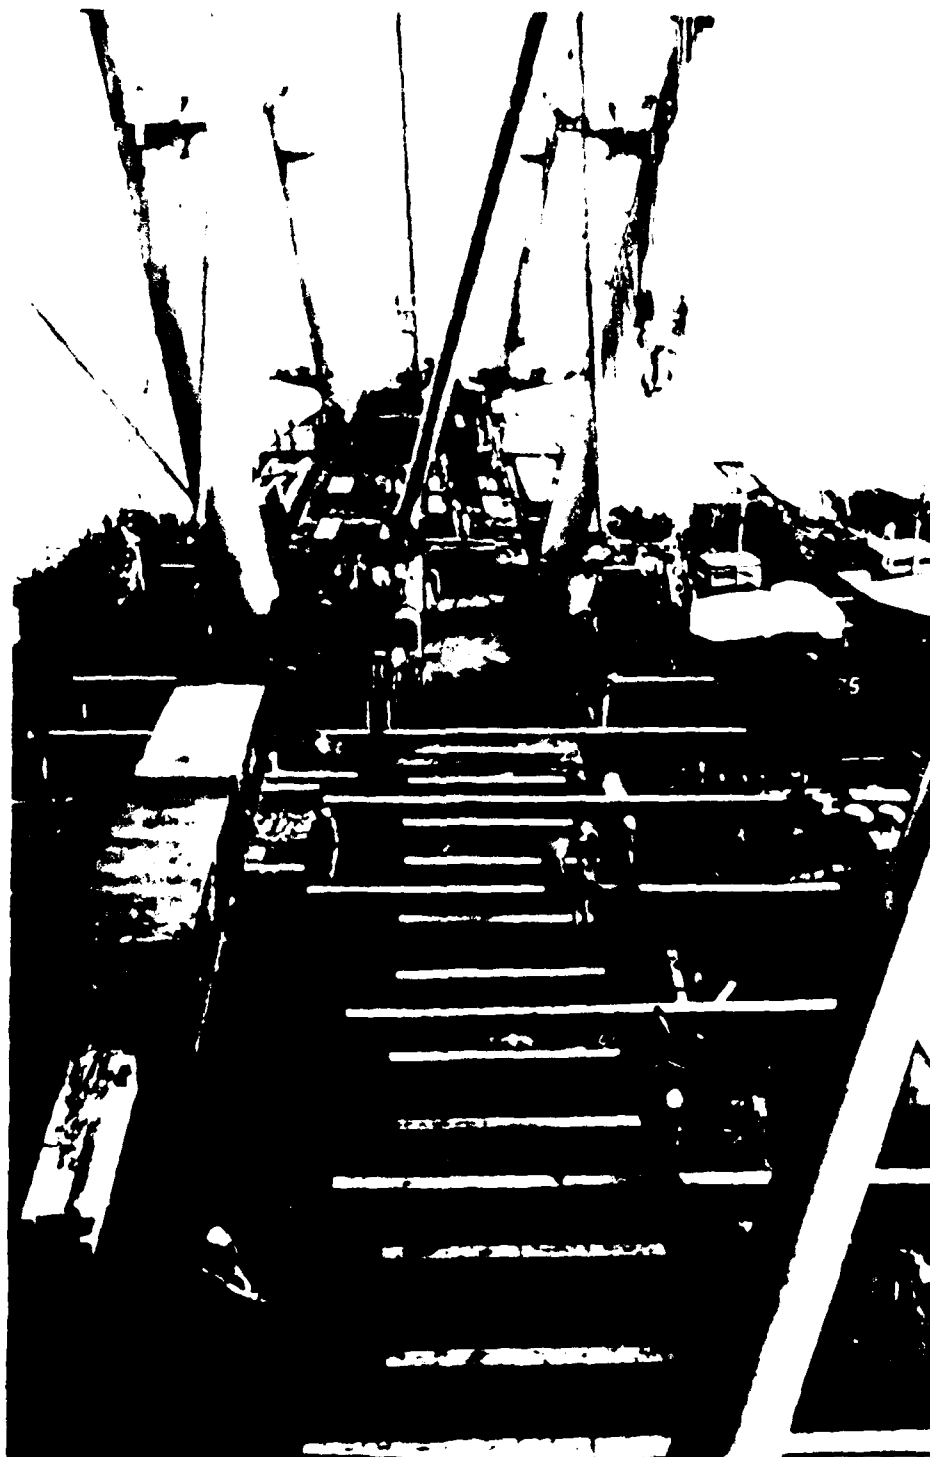
FIGURE 1.5. DECK PREPARED. Lunnage was laid on deck in preparation for the heaviest lift made in the LIFT pretest program, a 1466-class Army LC-16. Each of the two heavy-lift ships (the only heavy-lift ships currently in the U.S. flag fleet) can carry four of these large landing craft. A 1646-class LC-16 could not be lifted because neither the ship nor the Navy had the necessary sling.

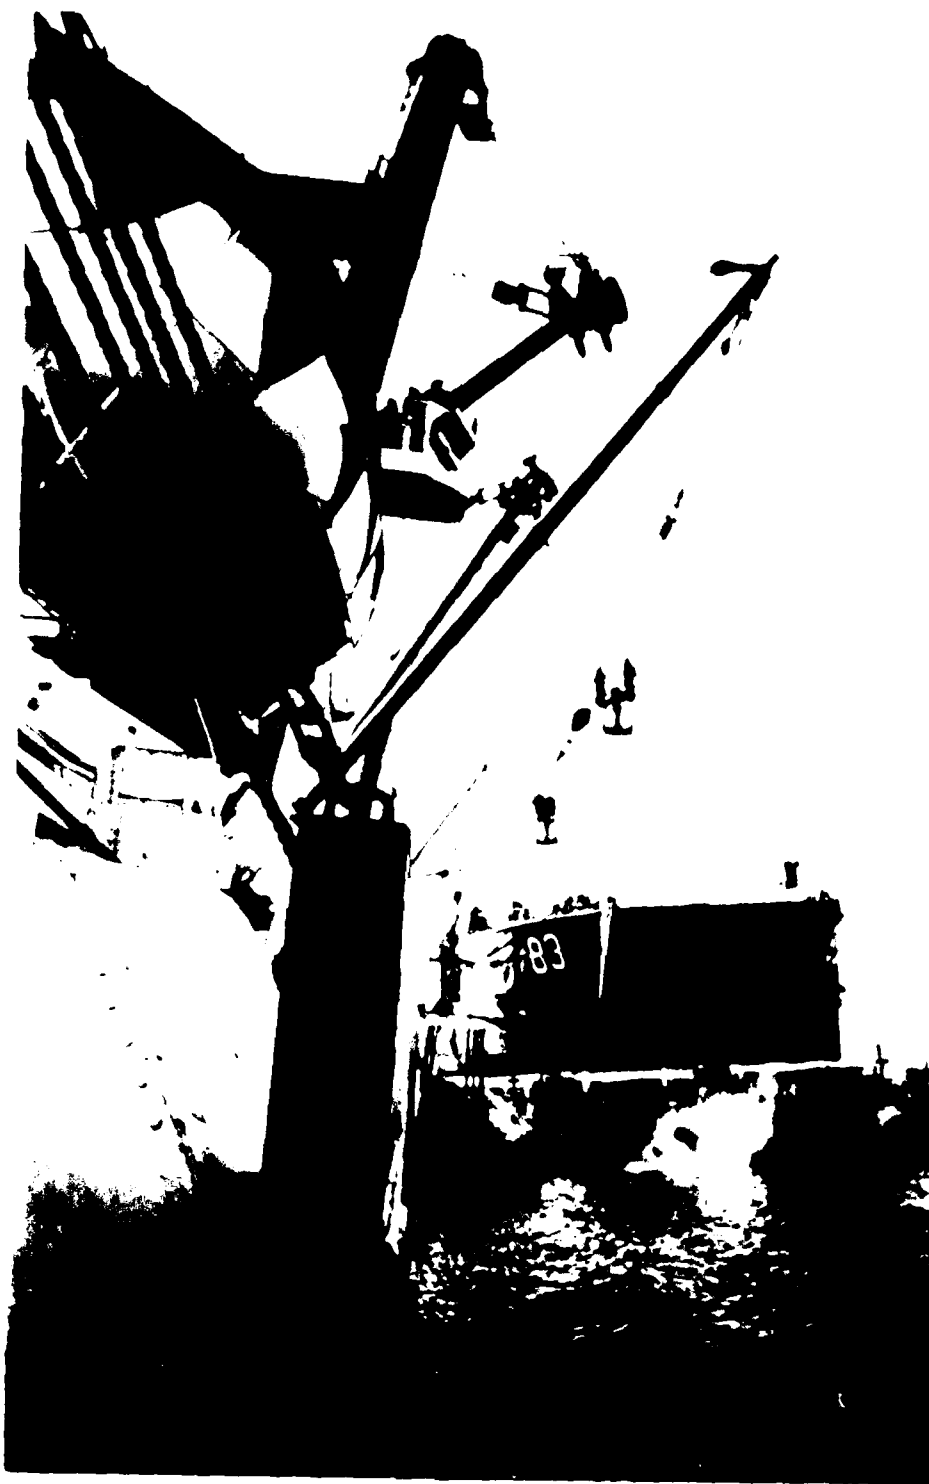
FIGURE 1. LIFTED WITH EASE. The LCU lift, although infrequently accomplished, was made with relative ease. Military personnel acted as stevedores but the ship's company operated all machinery and directed the technical aspects of the lift.

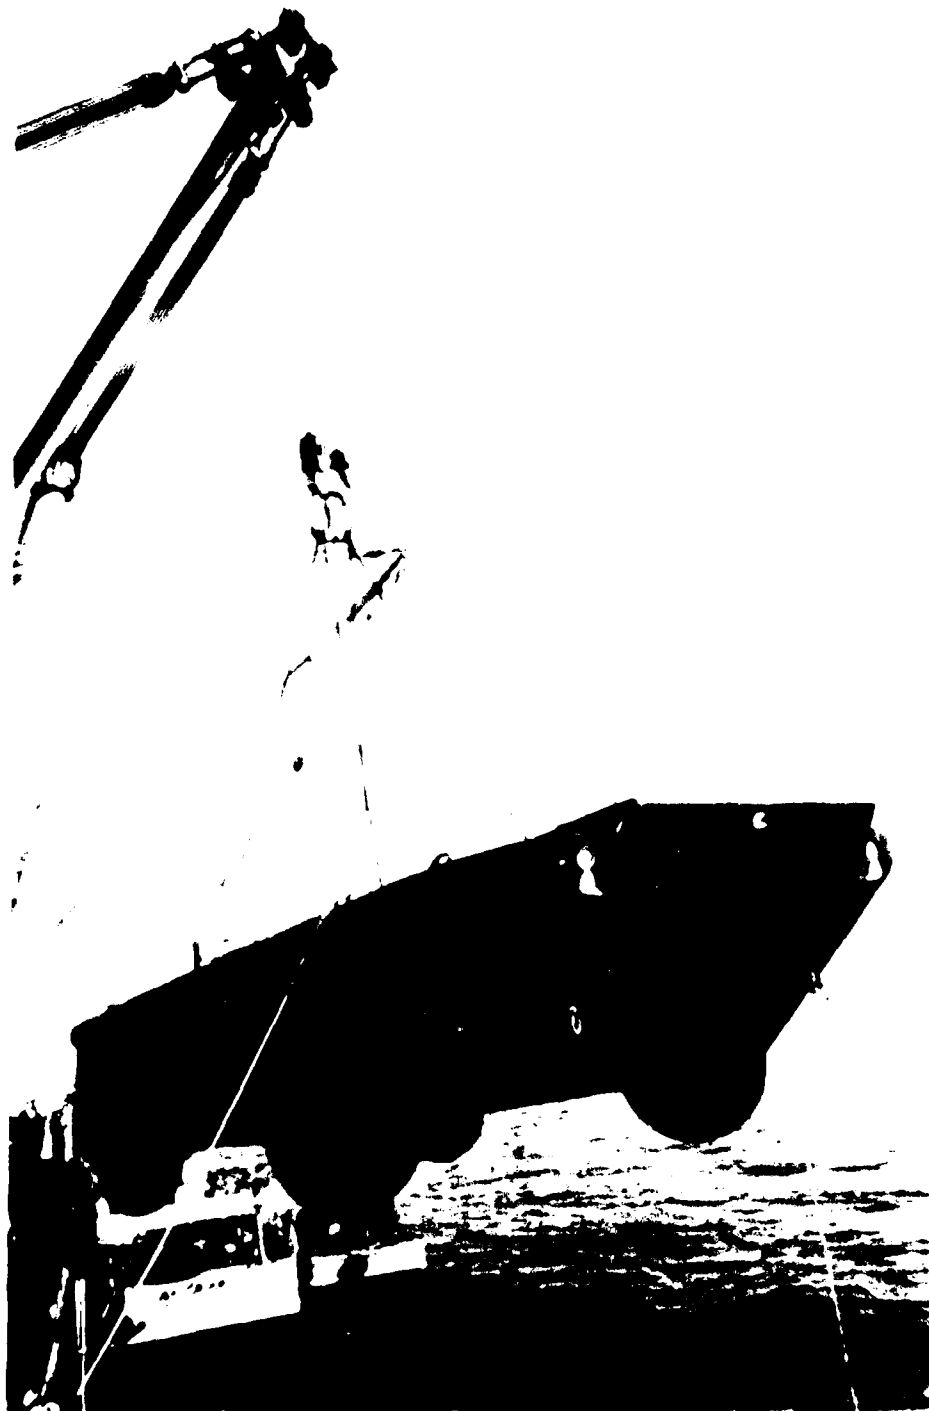
FIGURE 1. A vehicle is hoisted by the MIV-71. Approximately one-third of the 36-minute hoist time was spent waiting for the vehicle to land on the amphibious landing gear and was attributed to the 100-ton

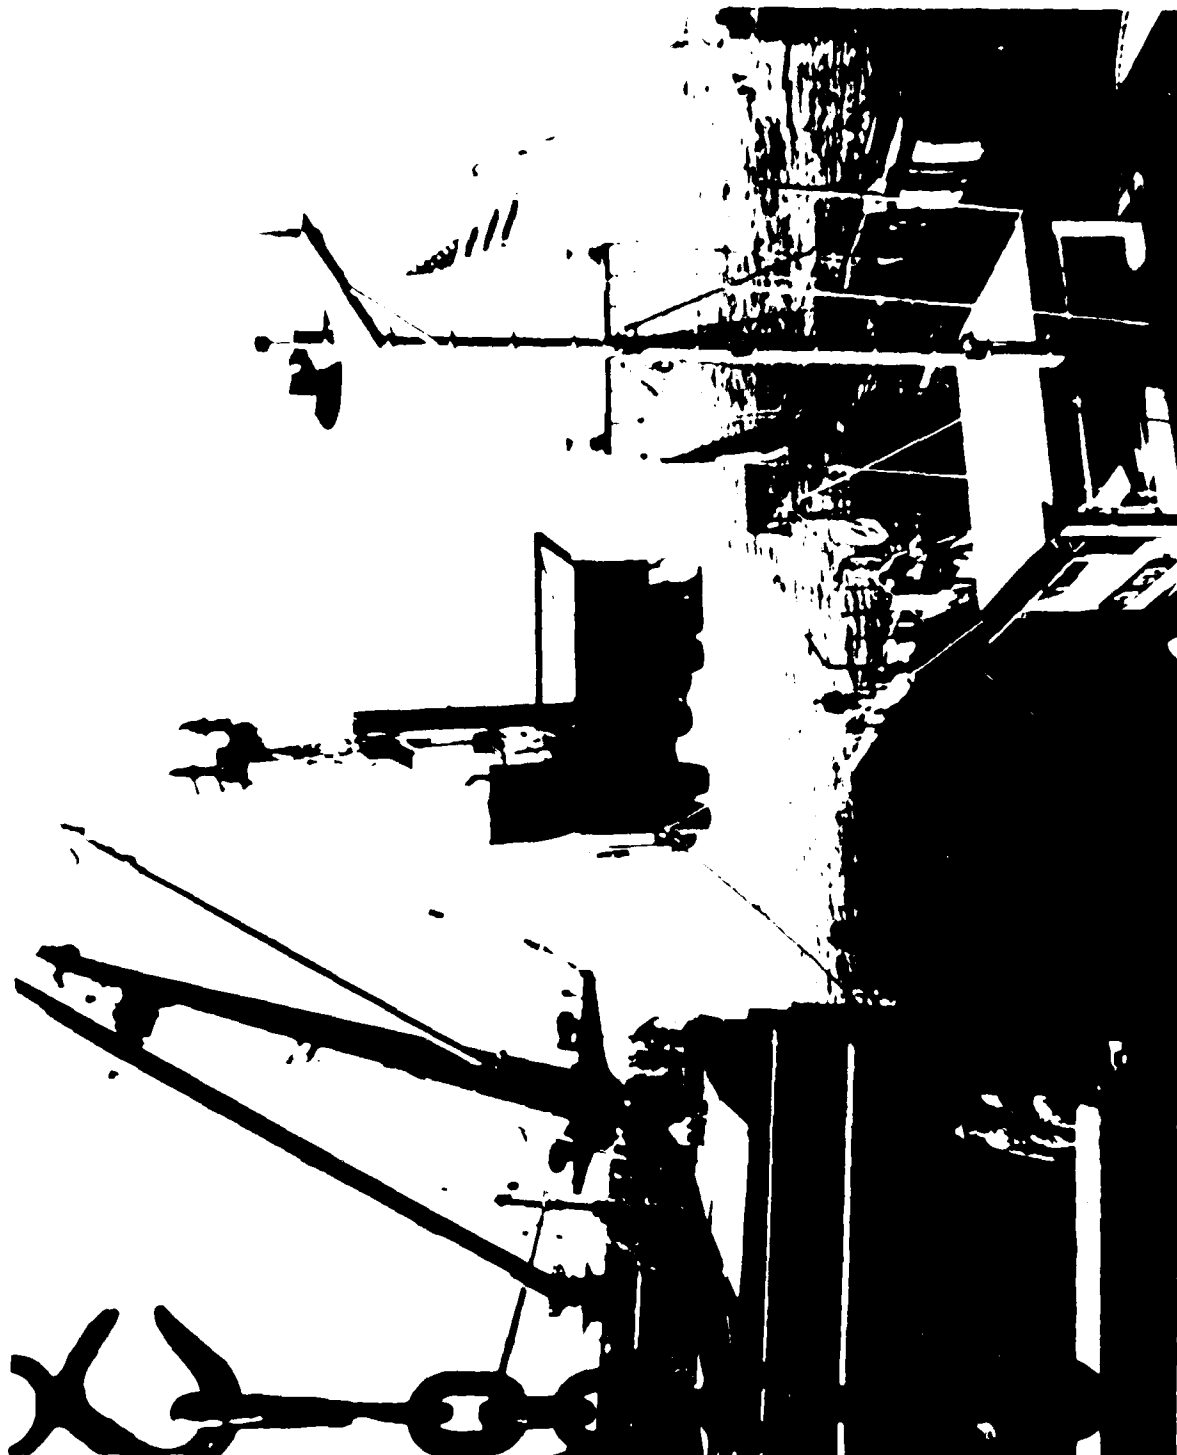
FIGURE D.29. SIDELOADER EASY LIFT. Compared to the other equipment embarked the sideloader went aboard relatively easily. It weighs 64 long tons and is 41 ft long, 12.5 ft wide, and 11.7 ft high.

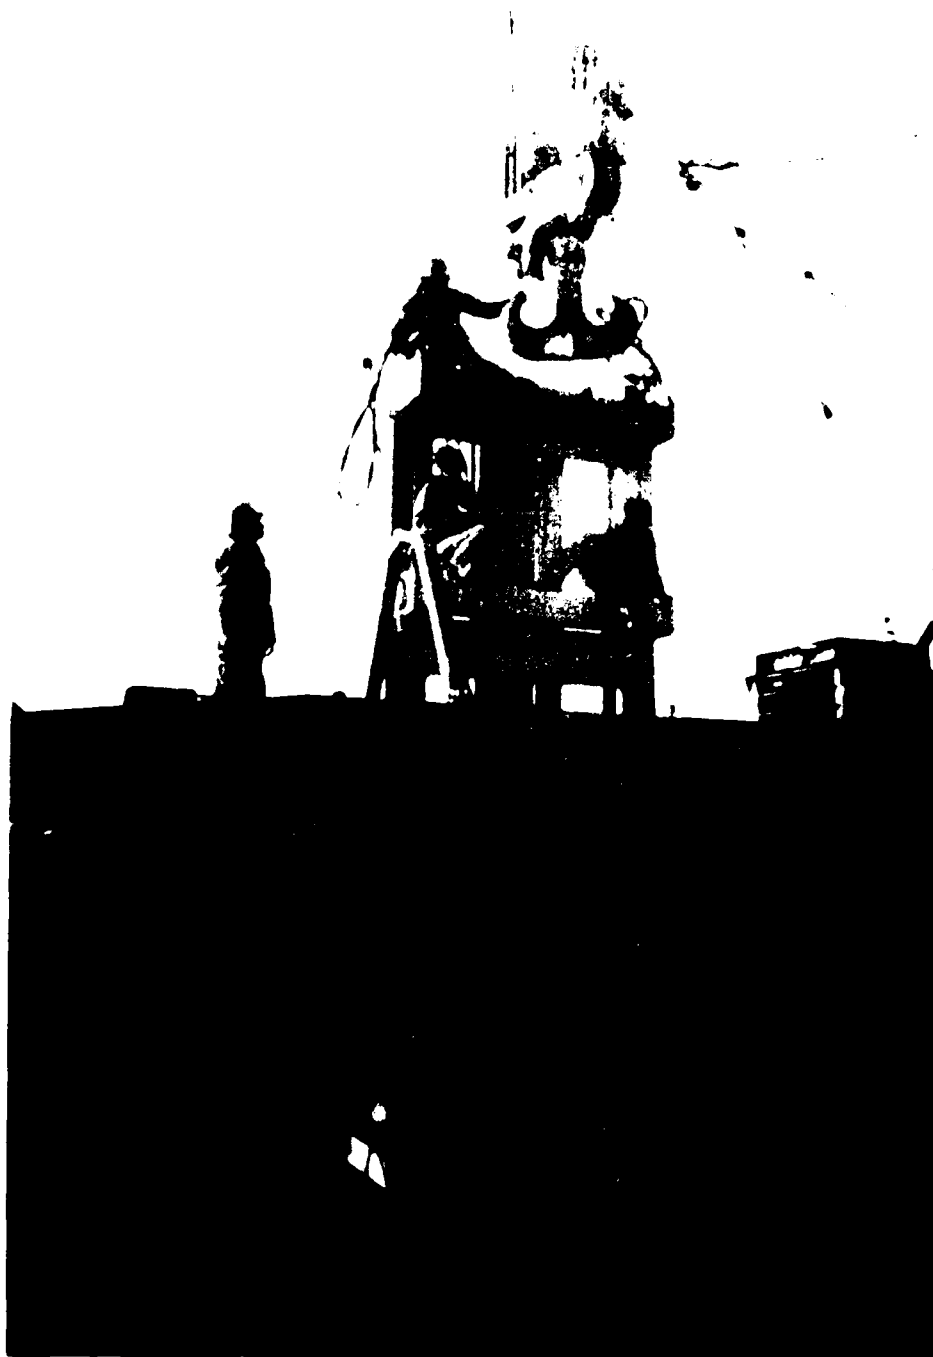
FIGURE 1.41. STEEL BEAM. Before lifting the steel beam for lifting it is necessary to climb up and attach the hook. The time to attach and detach the chokers on the hook required a total of 10 minutes for the loading cycle and 9 minutes during off-loading.

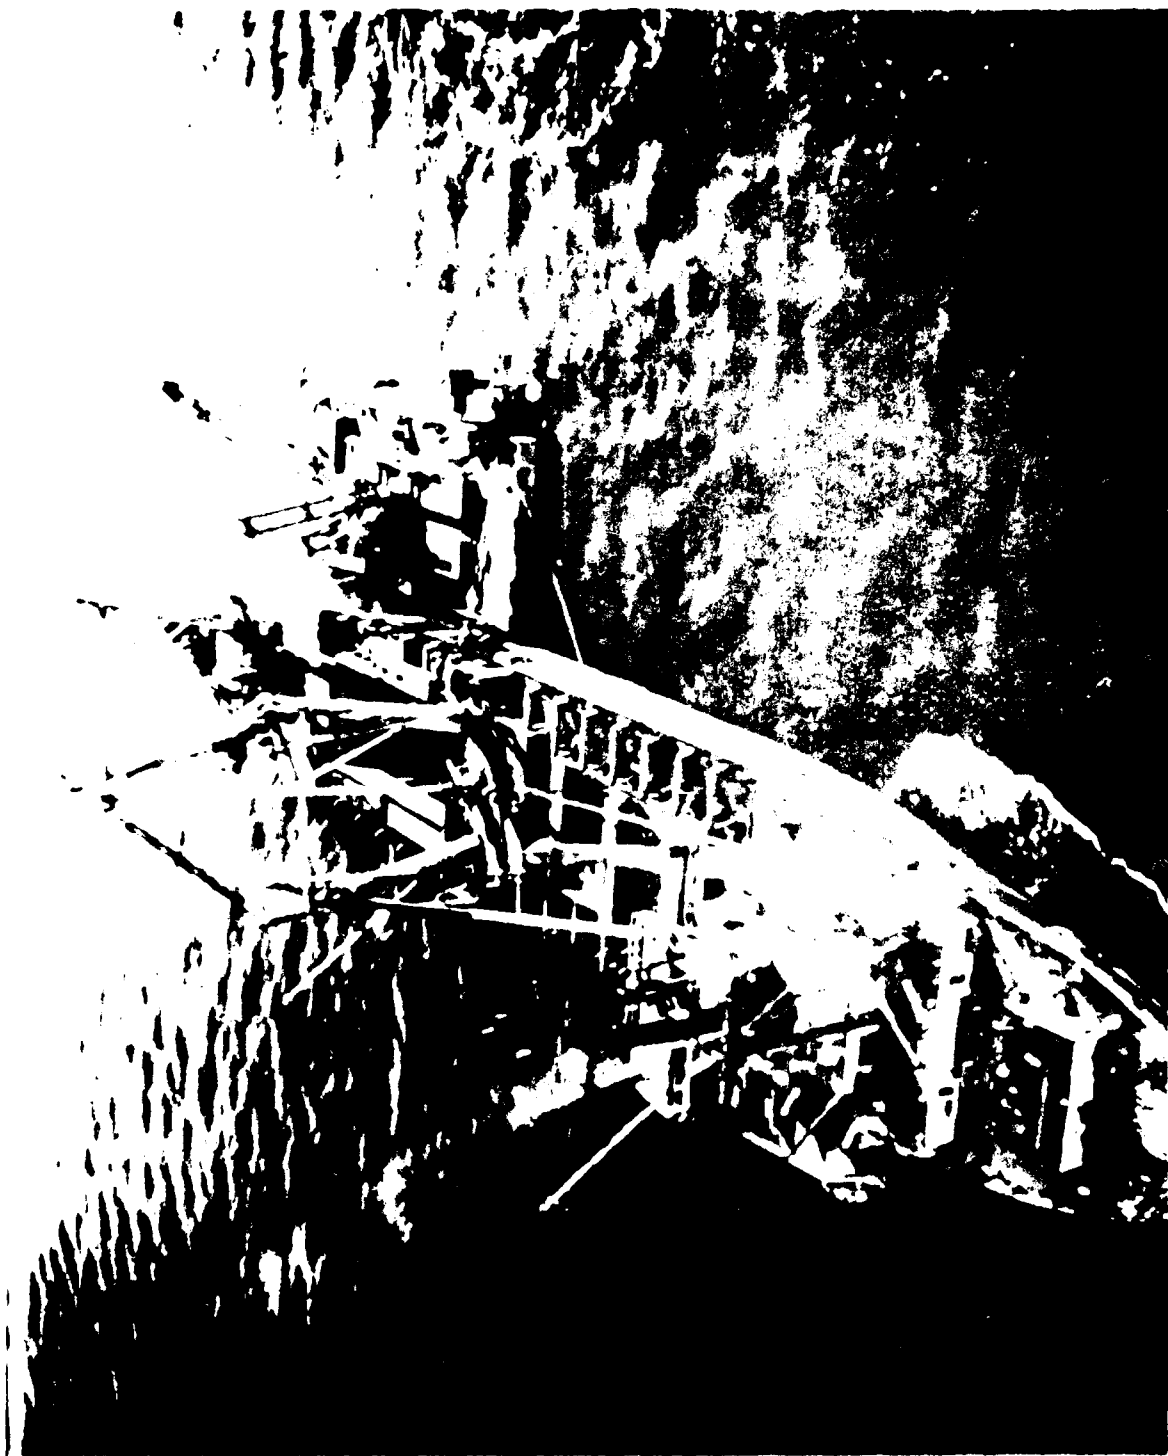
FIGURE 1. Operation of the B.W. After the initial load of containers had been discharged the TCCF was moved to the bow of the ship. Later, when the TCCF had swung into the gap at the bow shown in the photo above, the container spreader had to be turned further to line up with the containers. This was difficult because a two-point attachment was used between the crane and the spreader bar.

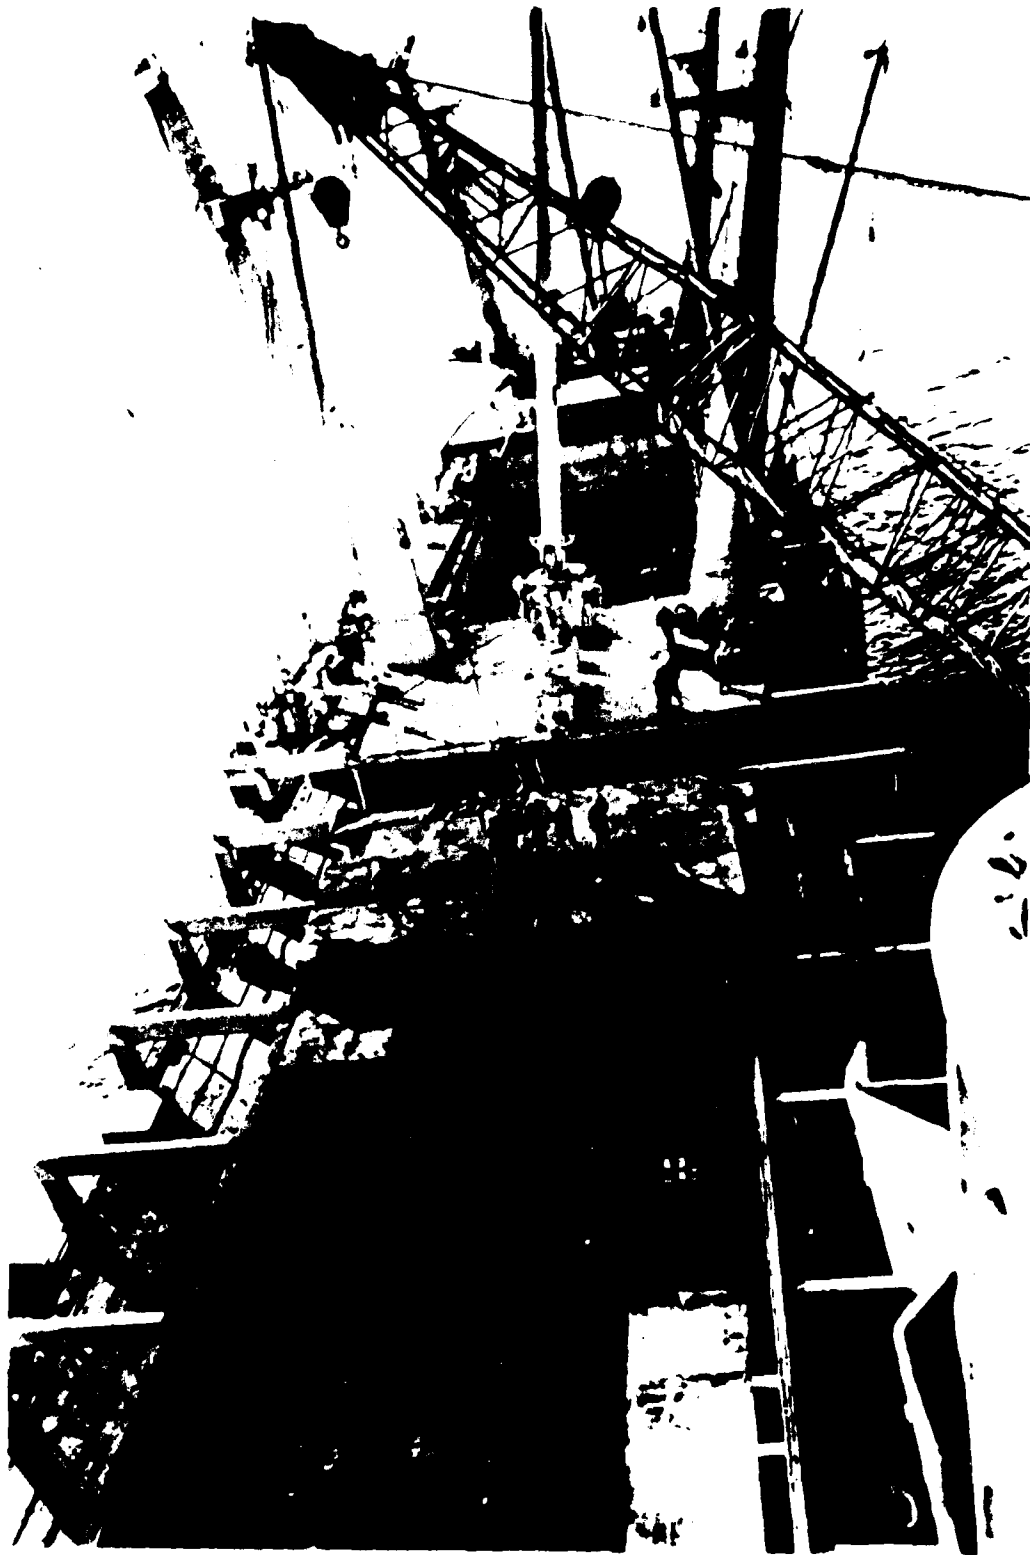
FIGURE D.37. TCDF OPENS HATCH. To gain experience and crane data on hatch square opening, the TCDF was used to remove the 5-ton sections of the hatch cover.

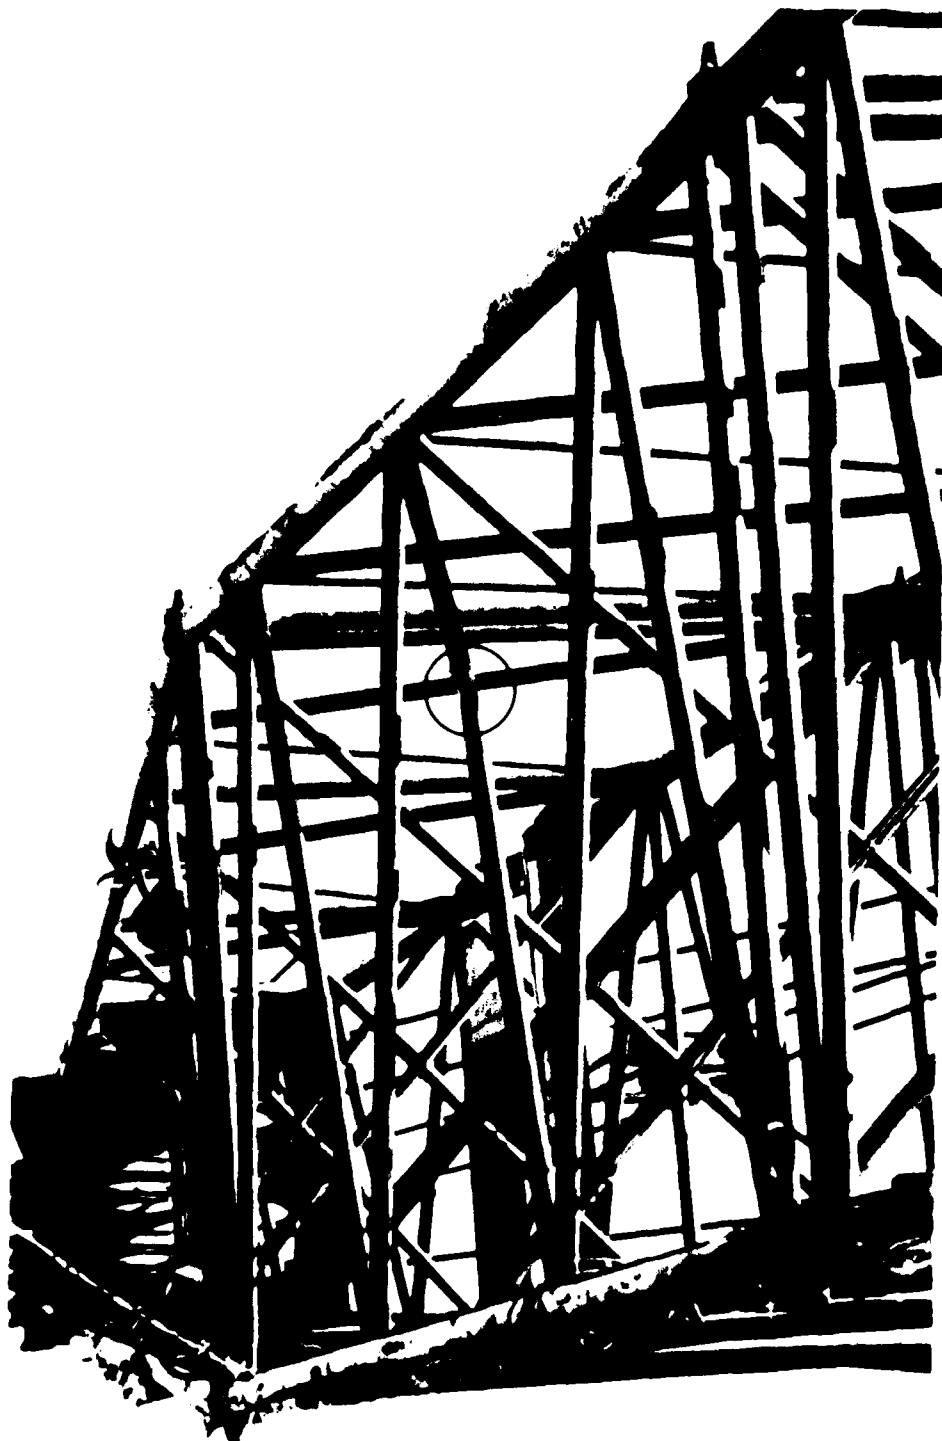
FIGURE D.38. BLOCK DENTS CRANE BOOM. On the first full day of container unloading the sea state caused the crane's block to pendulate during a break in the unloading. The heavy block struck the boom's tubing with sufficient force to seriously dent it.

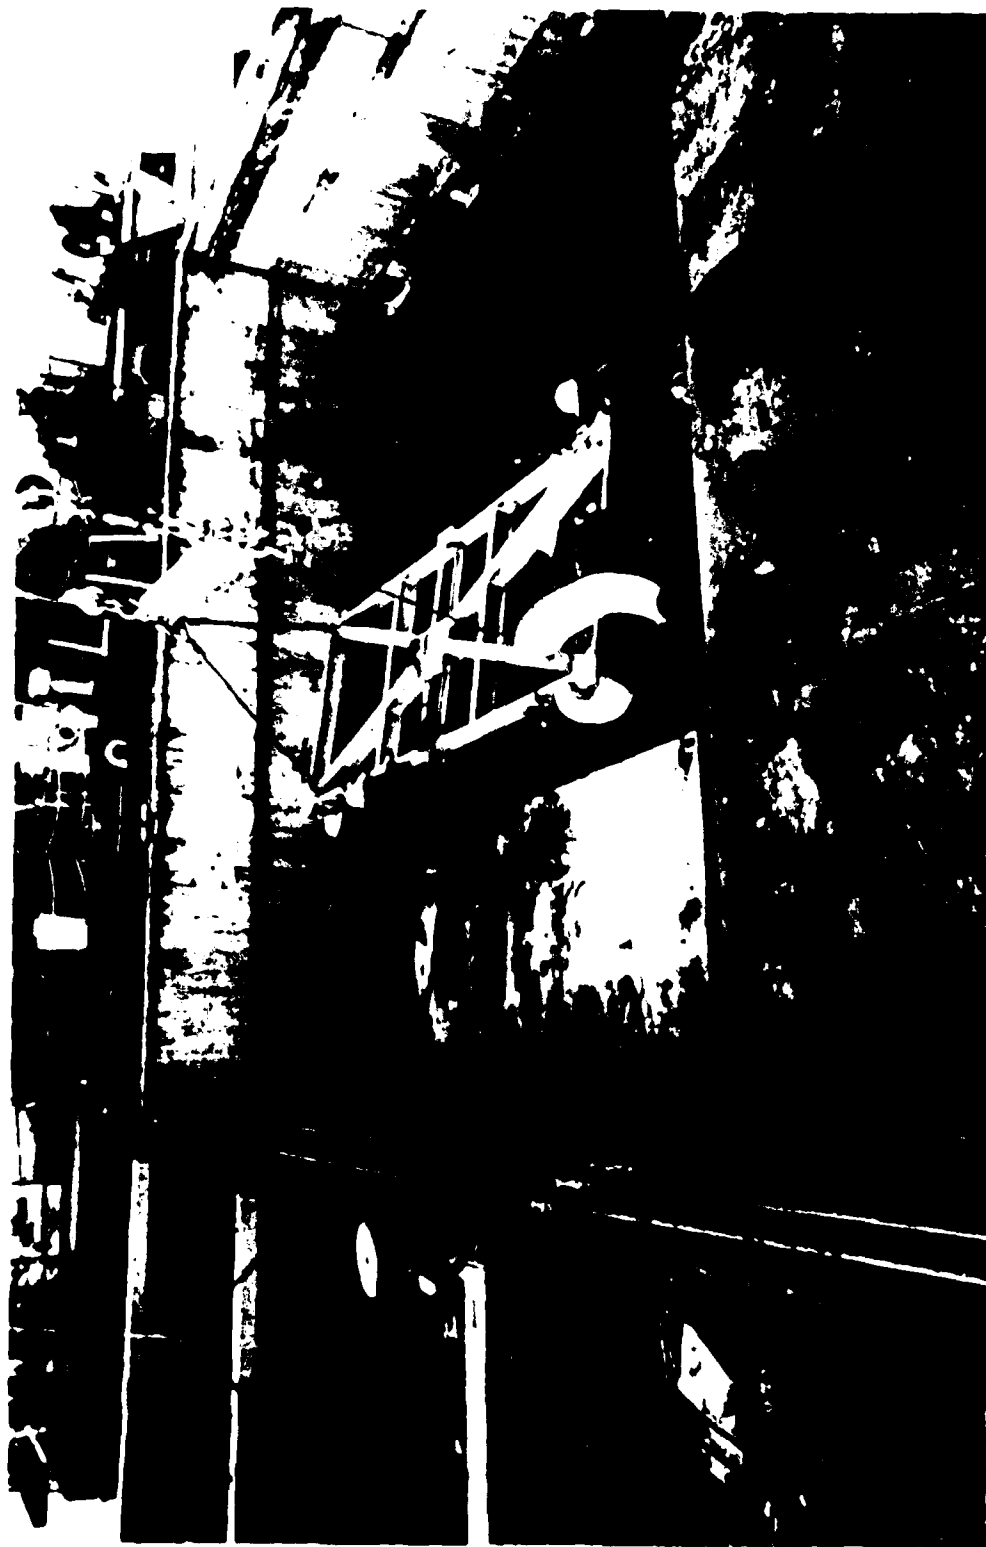
FIGURE C.39. POSITIONING SPREADER BAR. Without cell guides it was necessary to position the spreader bar manually in the hold. If the boom was not at a 90-degree angle to the container axis, delays and difficulties in attaching the spreader bar were experienced.

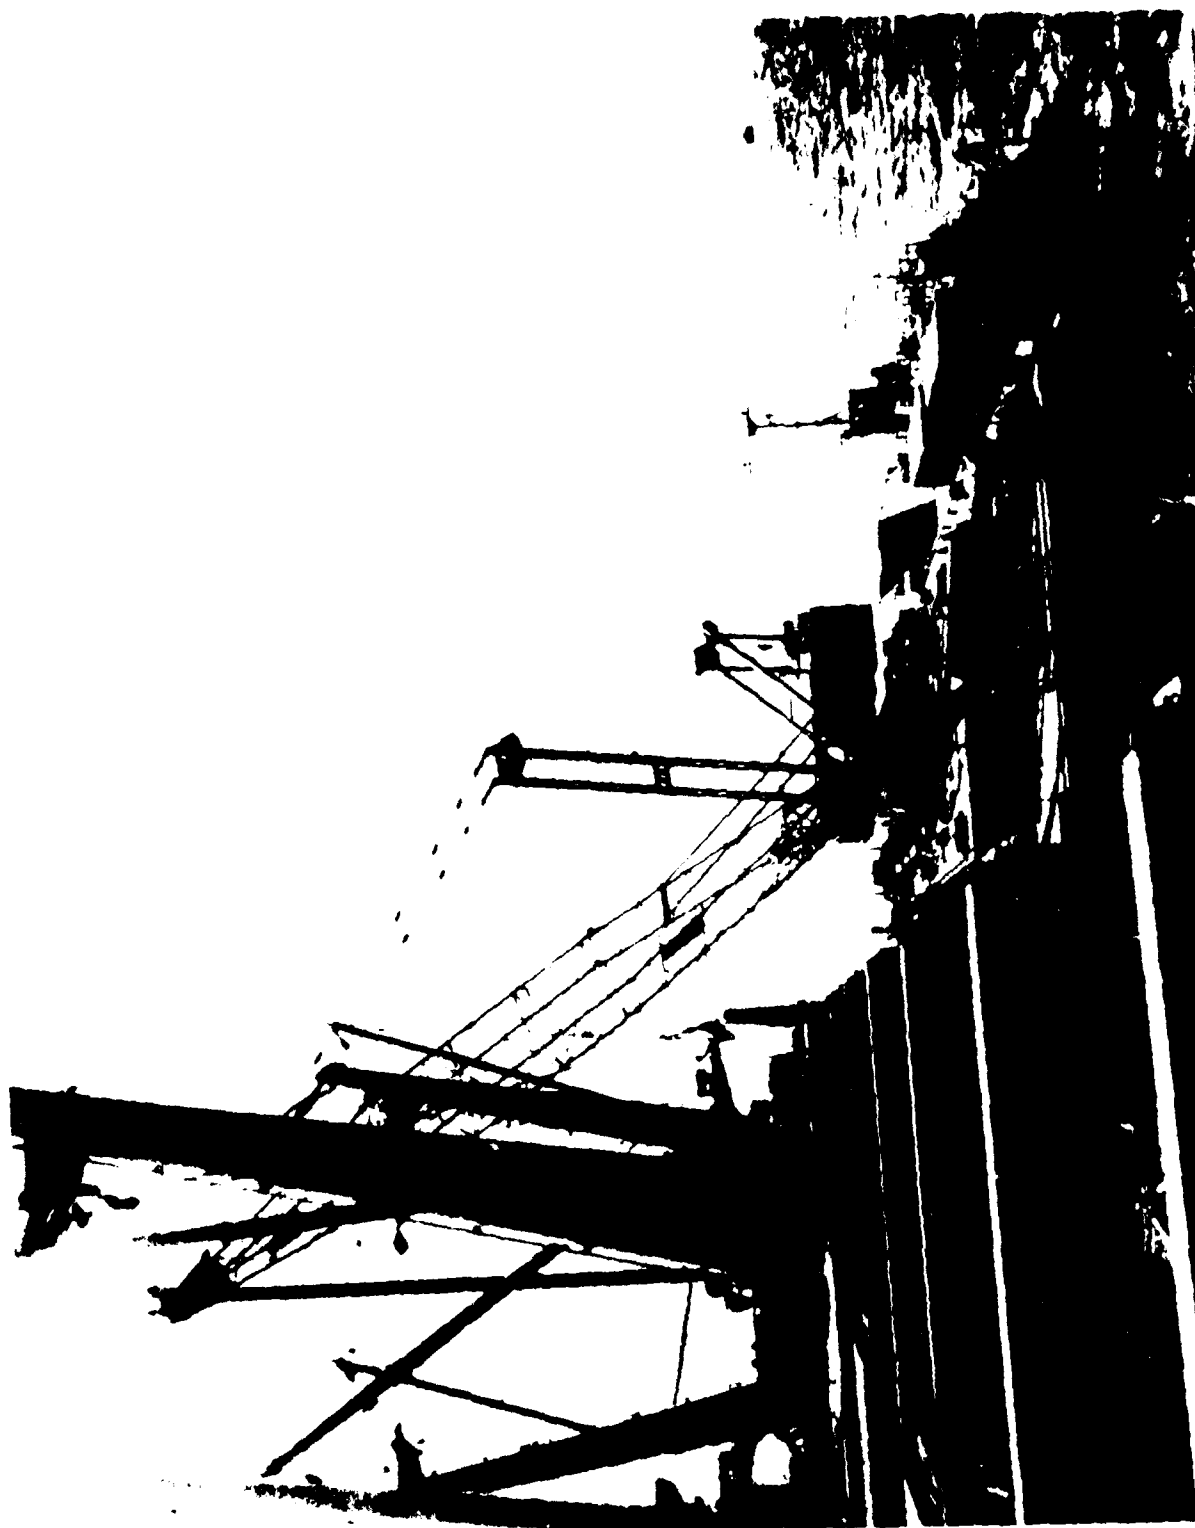
FIGURE 2-40. BOW TERS. Once the container was attached the crane had to top up as well as raise the hook in order to clear the ship's booms and kingposts. This led to delays to cycle times that would not be typical of operations on the clear deck of a container ship.

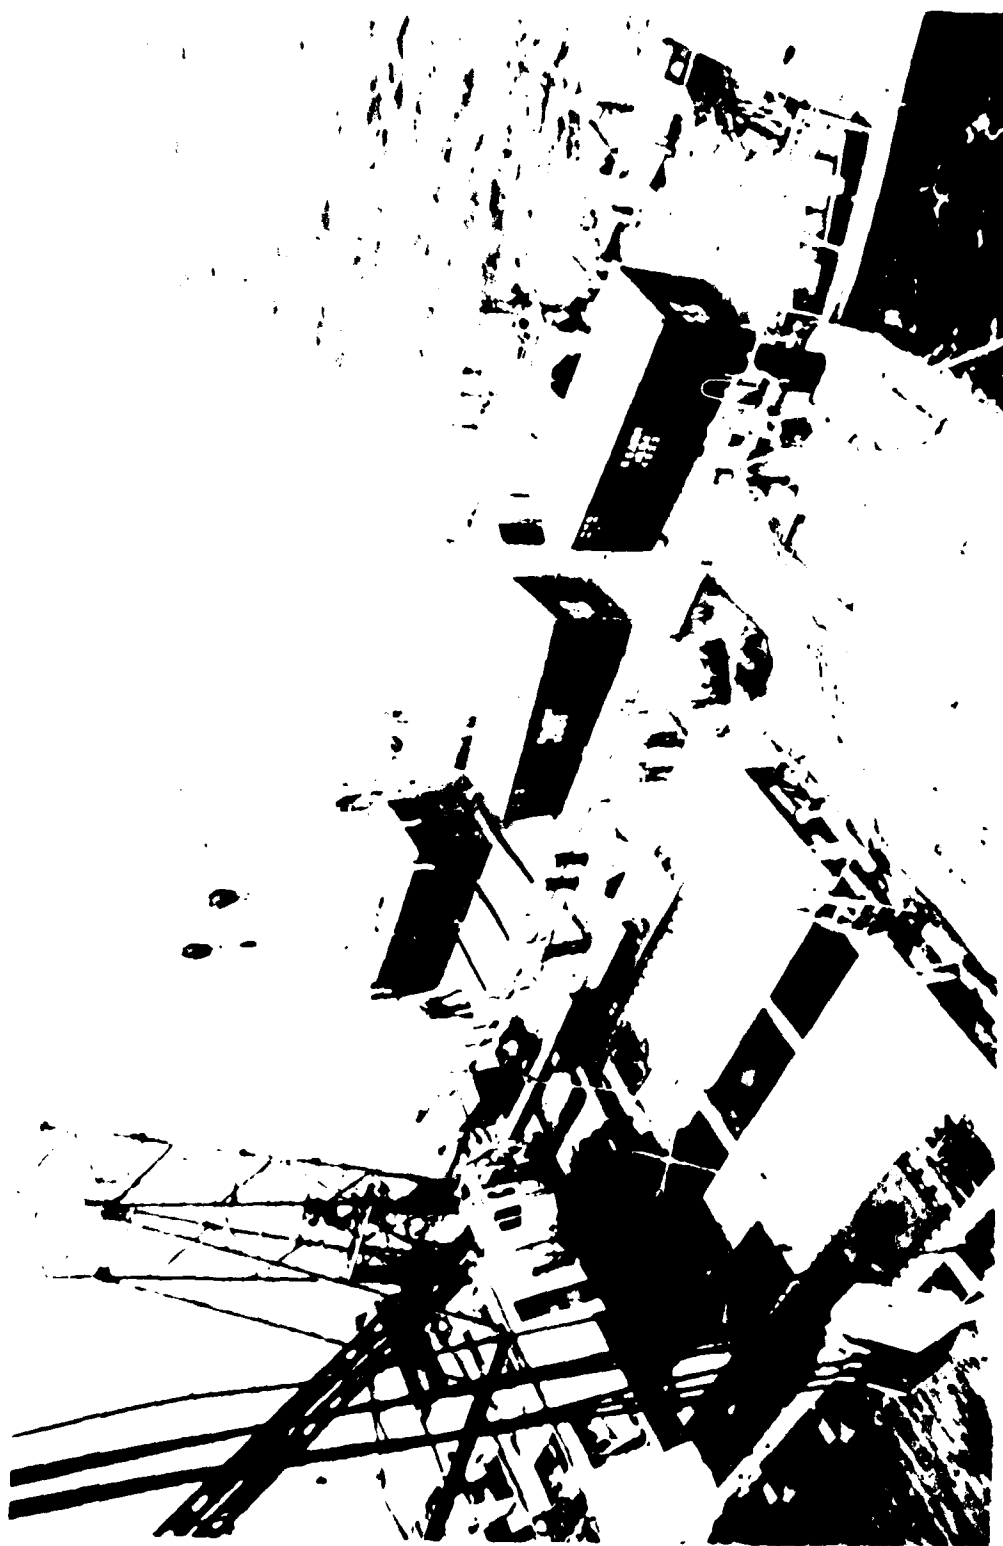
FIGURE D.42. LCU LIGHTLY LOADED. Normally an LCU would be loaded with four containers but because of the limited number of containers available, capacity loading was not practiced.

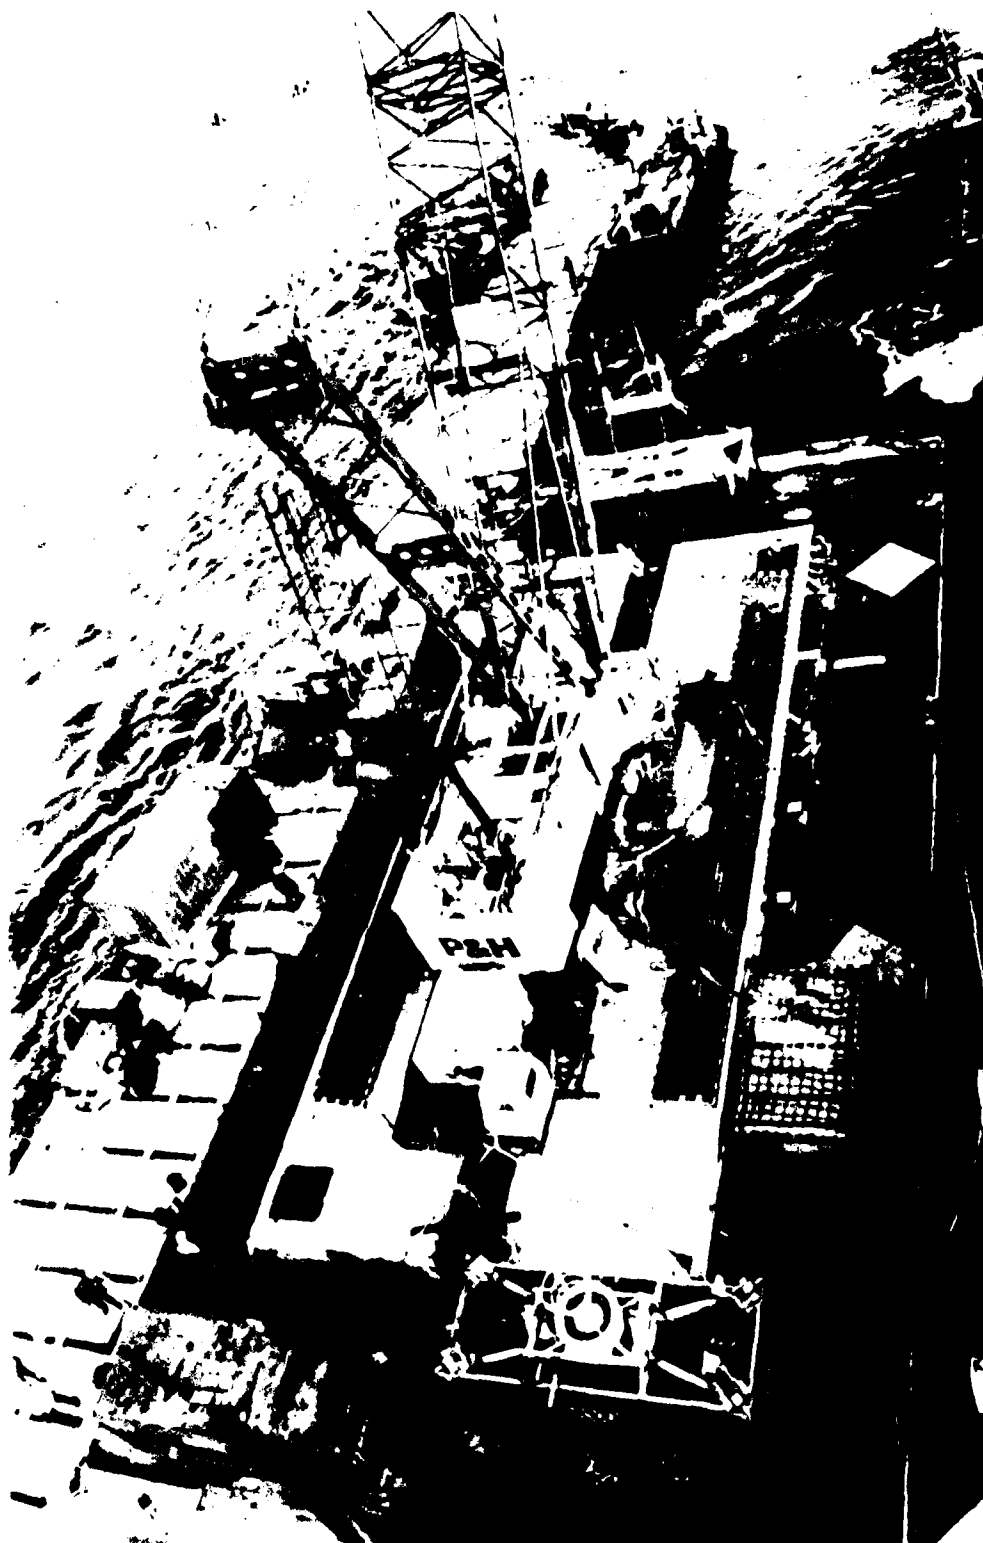
FIGURE D.43. MOBILE LOADING TIME-CONSUMING. One method of minimizing handling at the beach is to place trailers on a causeway ferry and load the trailers shipside. However, because of the motion of the seas and the need for close alignment during loading, it required approximately an hour to load just two of three trailers and it became apparent that the method was too time consuming.
